TECHNICAL REPORT EL-81-3

EVALUATION OF UNDERDRAINAGE TECHNIQUES FOR THE DENSIFICATION OF FINE-GRAINED DREDGED MATERIAL

David P. Hammer

Geotechnical Laboratory
U. S. Army Engineer Waterways Experiment Station
P. O. Box 631, Vicksburg, Miss. 39180

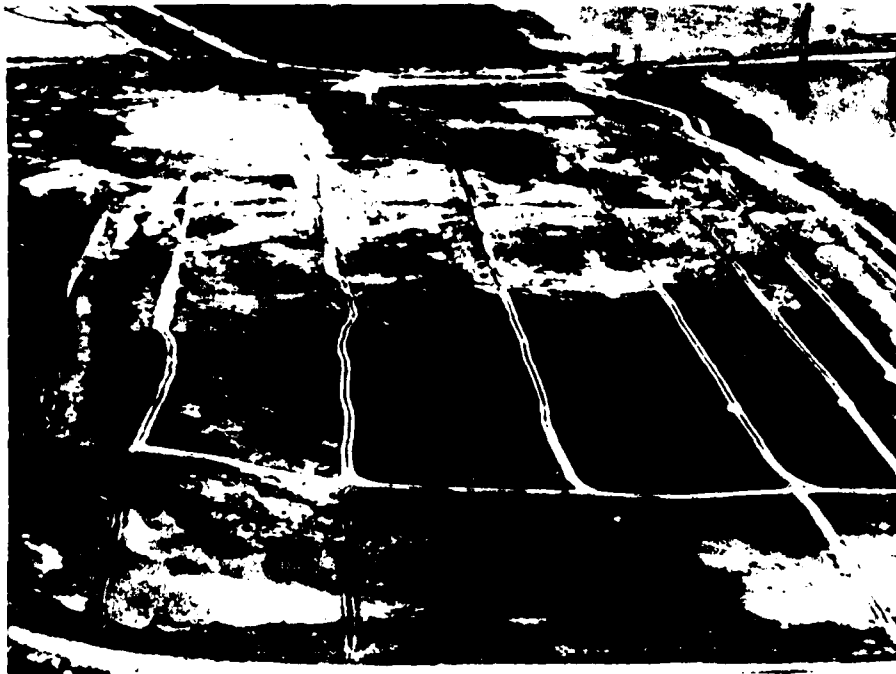
Figure 7. Aerial photograph of test site and borrow area

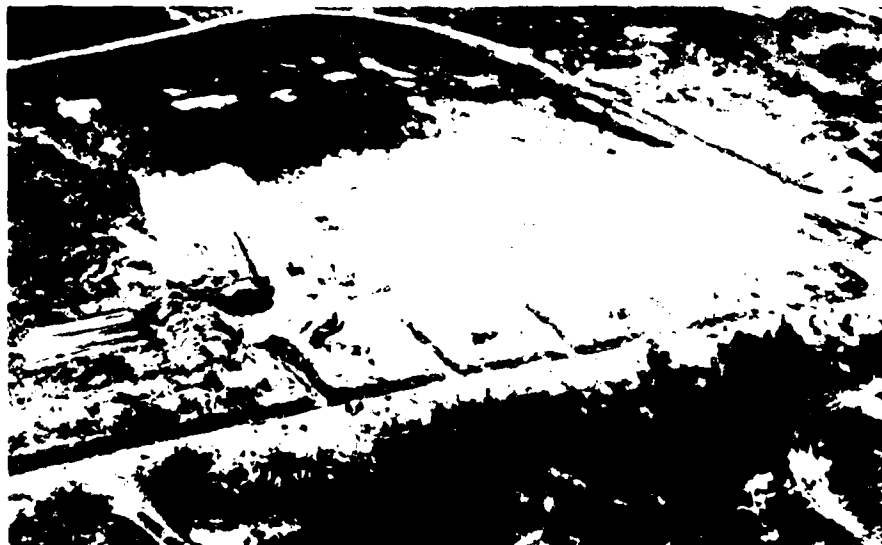
Figure 21. Aerial photo of test area following completion of ditching and rough grading

51. A dragline was also used for rough excavation and filling operations immediately after the ditching was complete. The site following completion of ditching and rough grading is shown in Figure 21.

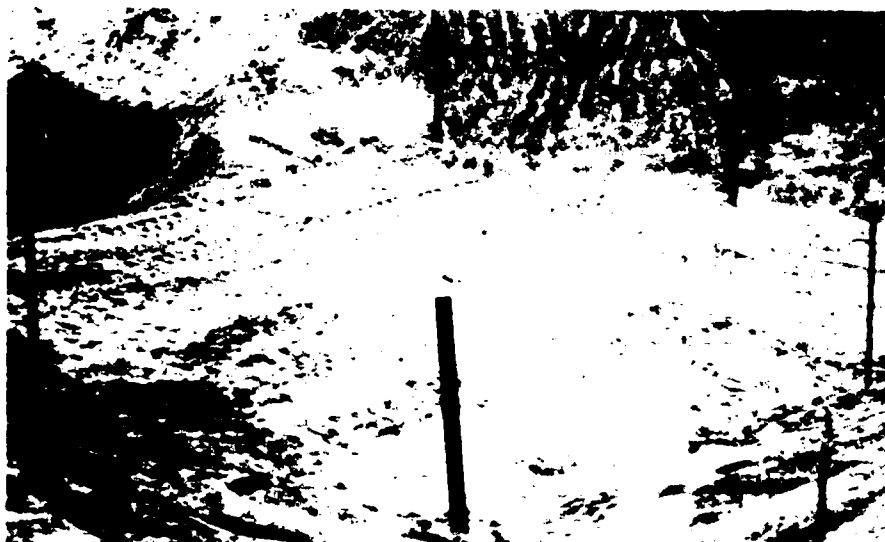
Figure 22. Typical test section before closure of back slope.

52. Fine grading was accomplished with a dragline and small dozers. Each test section was built to grade except for the back slope where the original drainage ditch was located (Figure 22). This slope

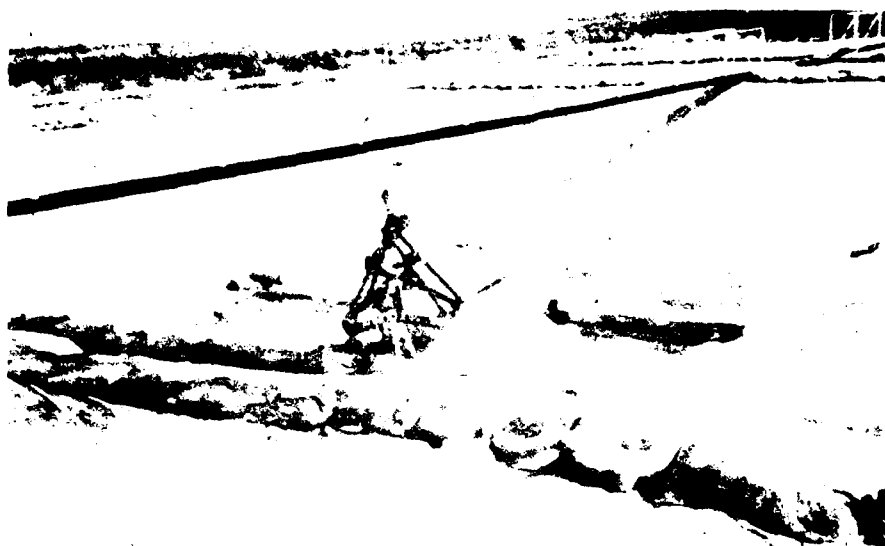
Figure 26. Placement of drainage material in test section 1

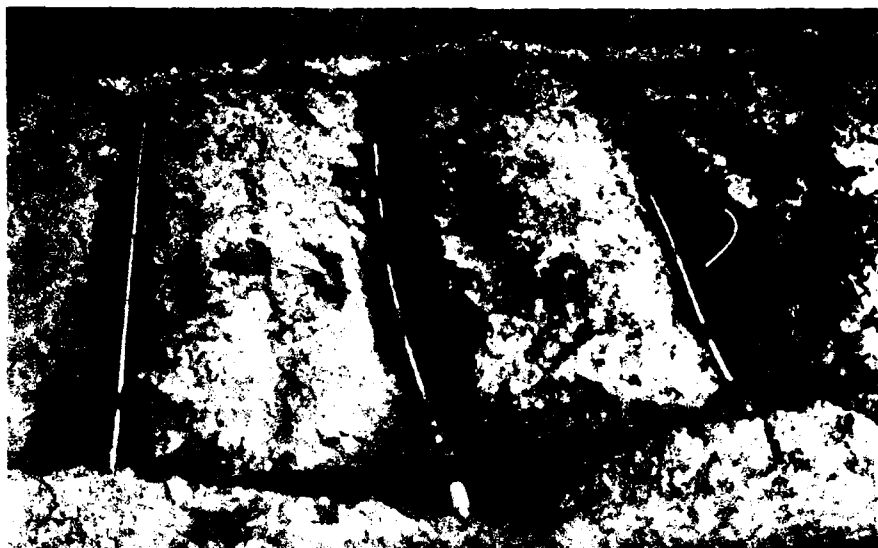
Figure 27. Slotted collector pipe in trenches
(test section 2)

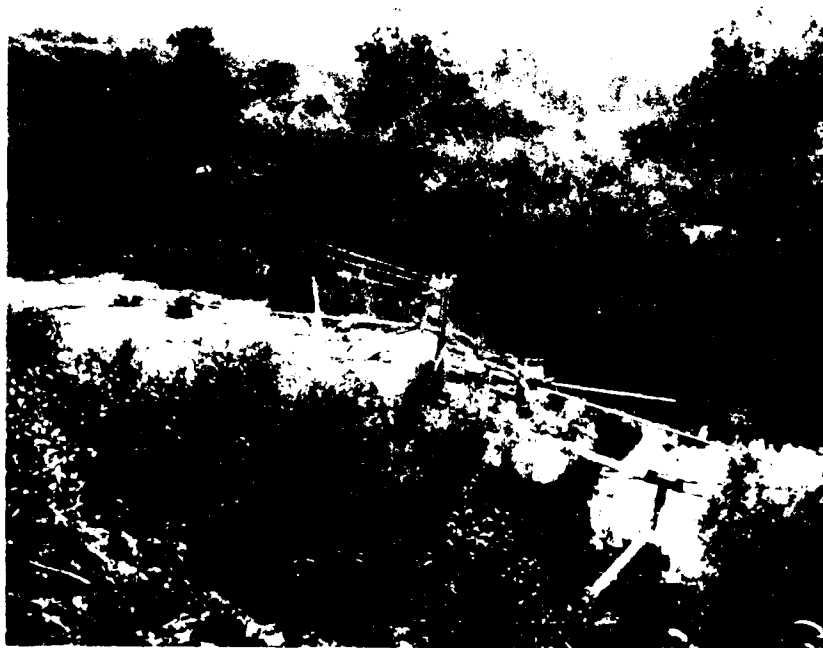
Figure 30. Typical vacuum pump installation.

57. Following completion of the underdrainage layer with collector system, sumps and sump pumps were installed in test sections 1 and 4 and vacuum pumps in test sections 2 and 3. All of these pumps were located at the outside toe of their respective test section slopes. Figures 29 and 30 show typical completed systems of sumps and sump pumps and vacuum pumps, respectively.

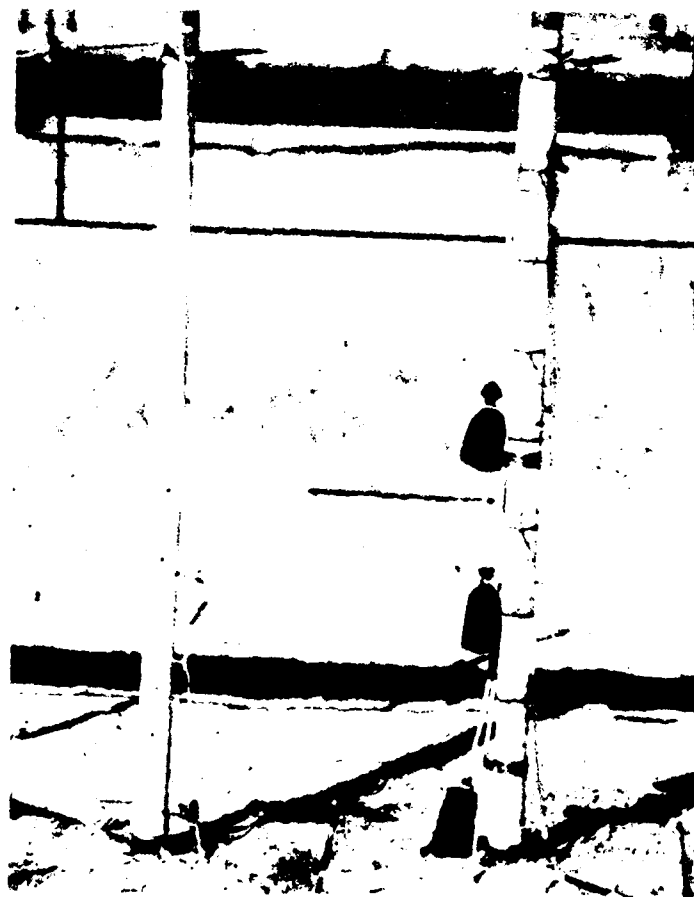
Figure 31. Piezometers in place on a settlement plate riser and on an instrument stand

61. One settlement plate to measure settlement of the under-drainage layer and foundation was installed in each test section. A typical in place settlement plate with riser is shown in Figure 31 (on left). As previously mentioned, these devices, which were carefully plumbed and leveled, also served to support the WES transducer piezometers. A hole was cut in the side of the bridge for the riser pipe and strapping was carefully placed around the riser to help hold it in place, but not bind it. Zero settlement reference elevations for these devices are given in the following tabulation.
